**BLM Cedar City Field Office
Site Inspection Report**

File: UTU-78613
David Penney: Lost Gems Project

Insp. Date: July 2, 2013

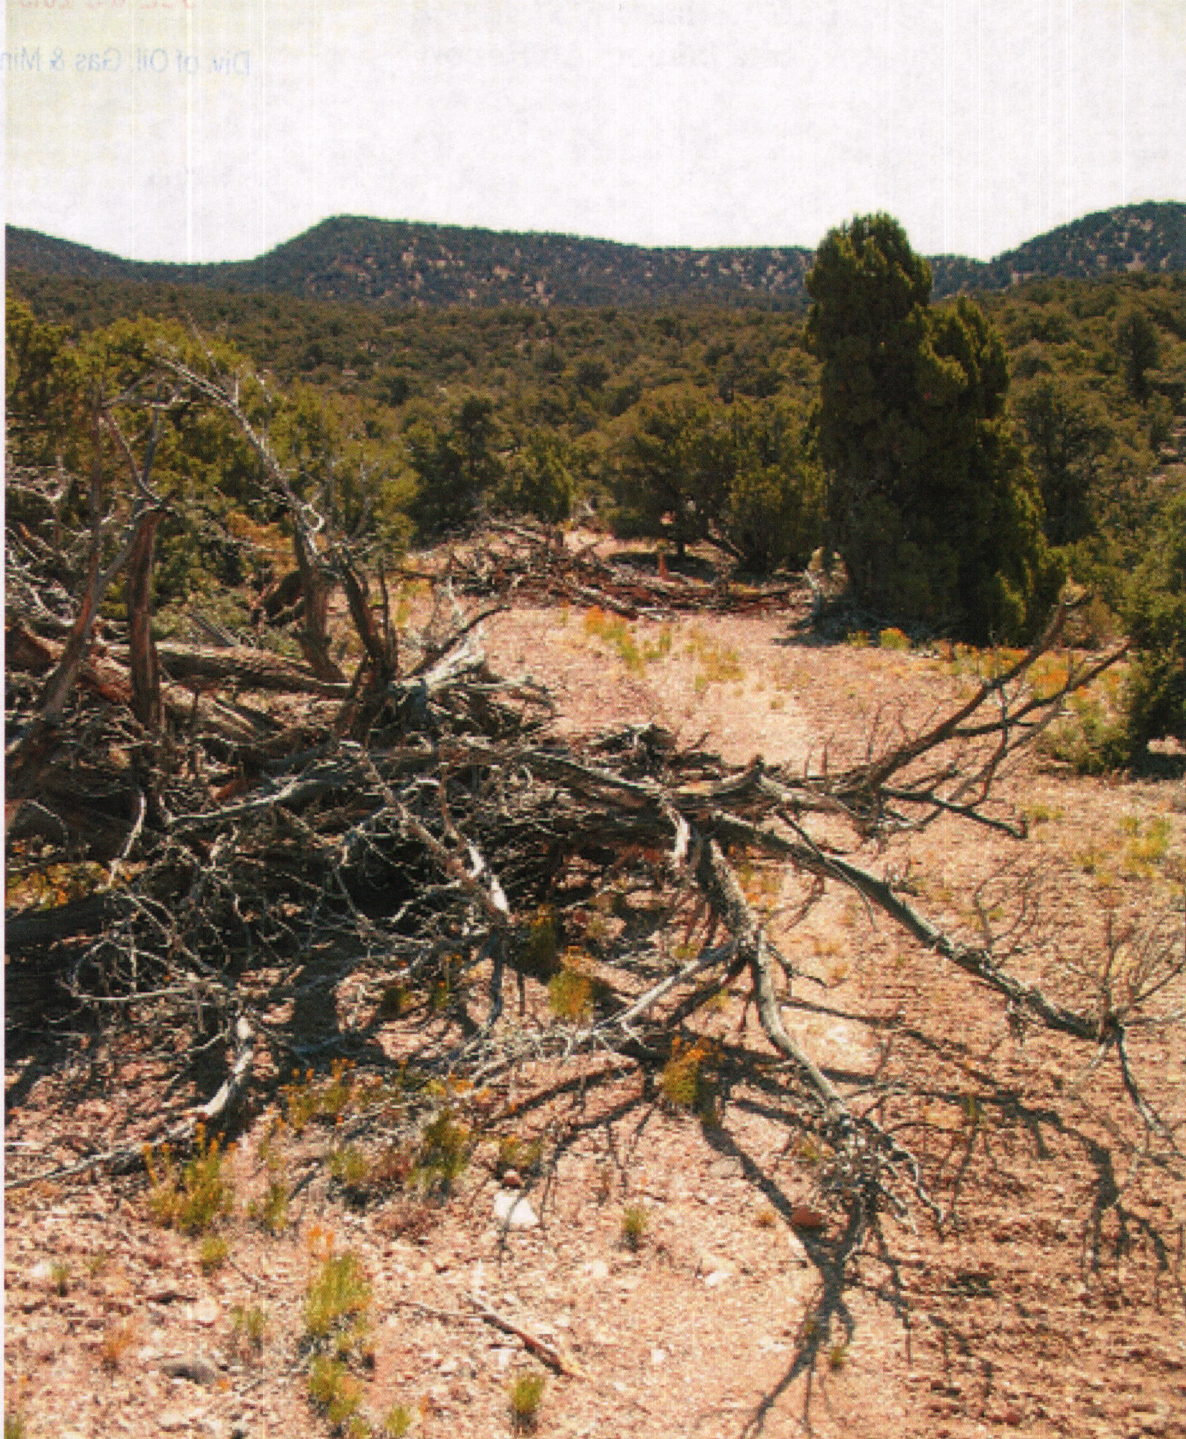
UTU-78613: Lost Gems
July 2, 2013

Typical section of access trail to prospect pits with dead and down trees dragged back on the trail.

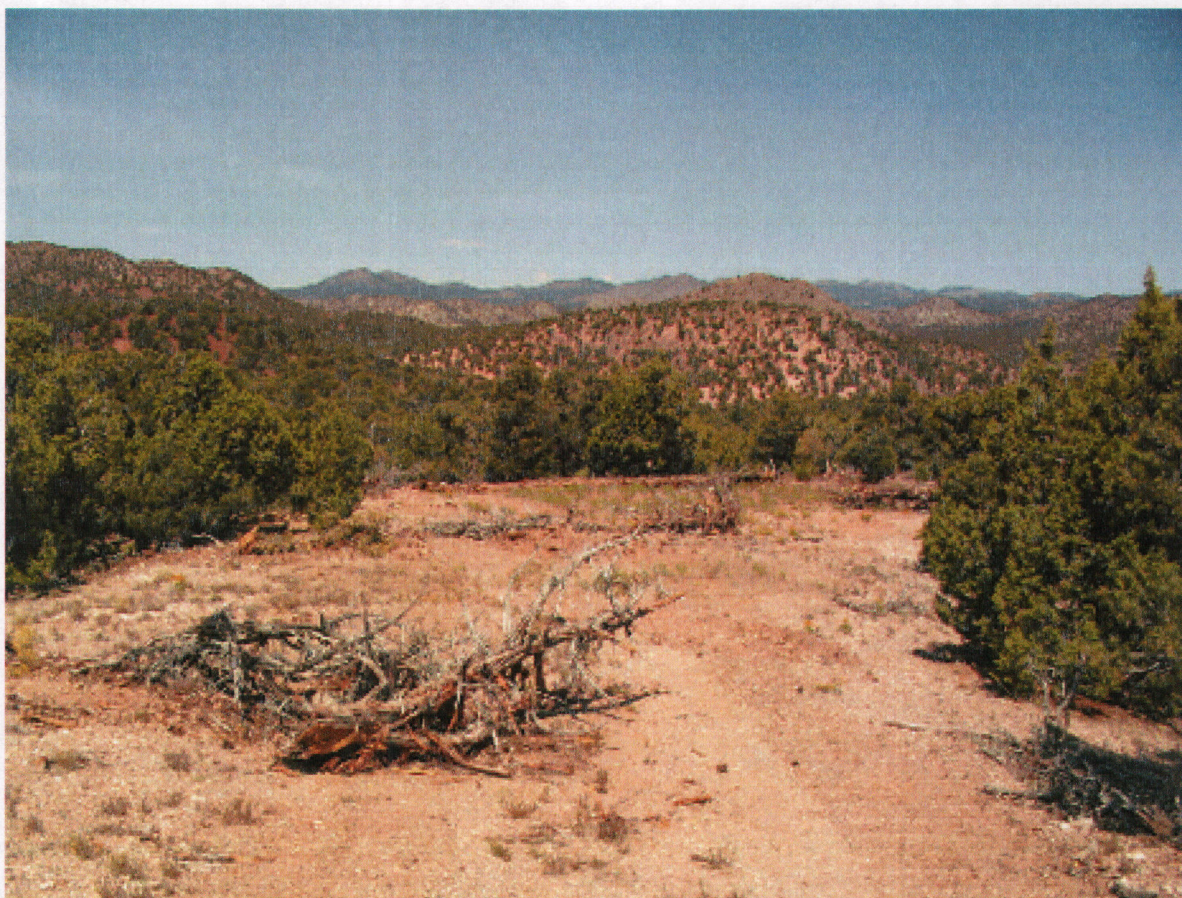
UTU-78613: Lost Gems
July 2, 2013

Typical section of access trail to prospect pits with dead and down trees dragged back on the trail.

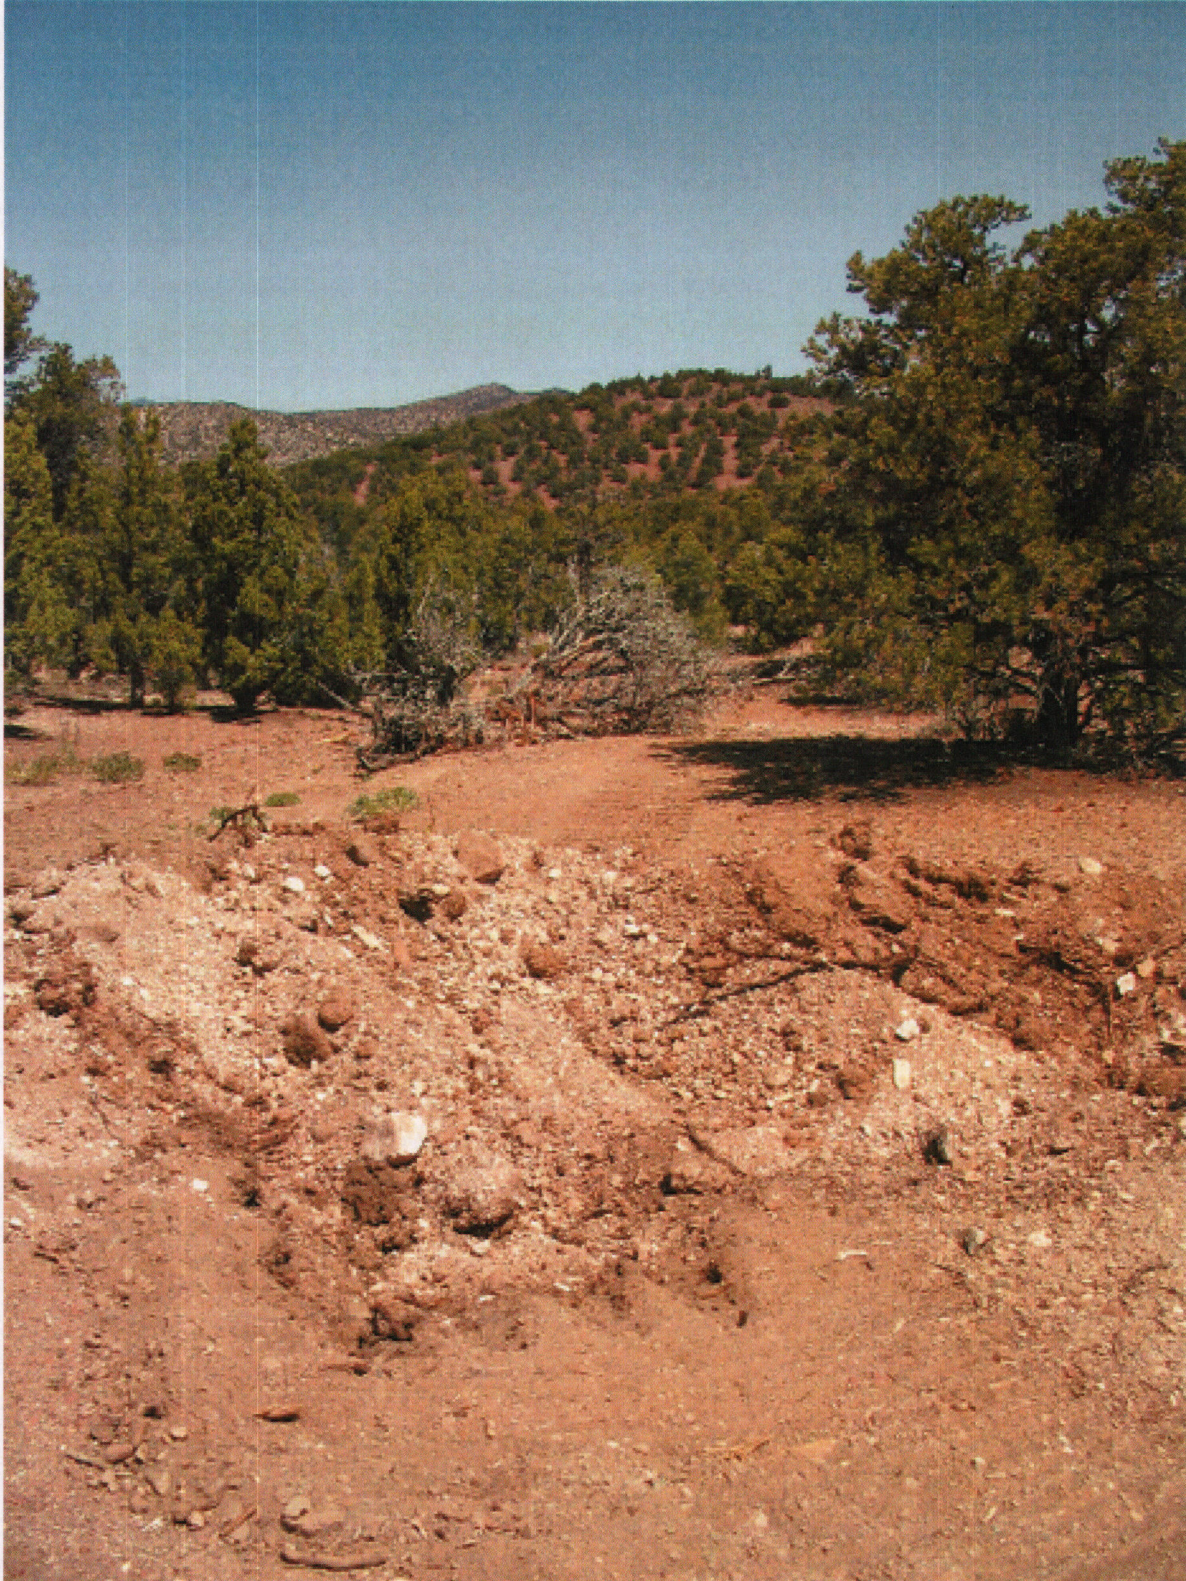
UTU-78613: Lost Gems
July 2, 2013

Example of trenching across the road to prevent future vehicle travel.

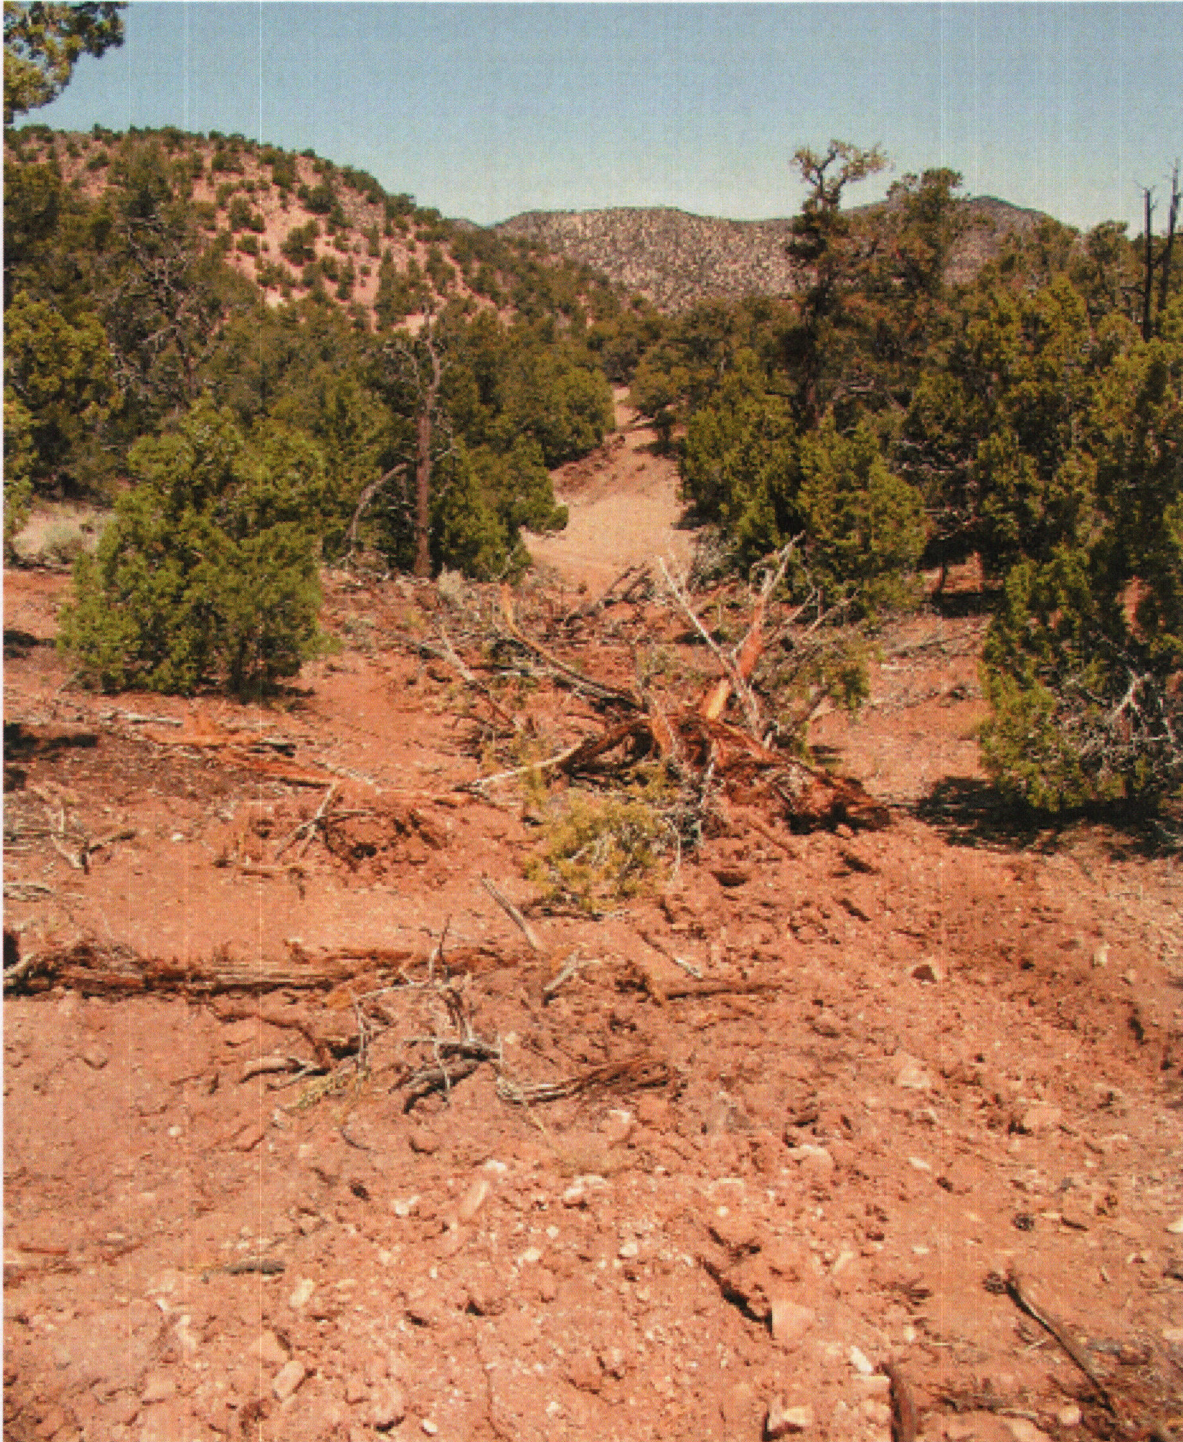
UTU-78613: Lost Gems
July 2, 2013

Typical section of access trail to prospect pits with dead and down trees dragged back on the trail and trail surface deeply ripped.
